DEPARTMENT OF NATURAL RESOURCES  
DIVISION OF OIL, GAS AND MINING

RE: Site Inspections; International Uranium; Hecla Shaft, La Sal-Snowball, Pandora, and Redd Block IV Projects; M/037/043, M/037/026, M/037/012, M/037/046; San Juan County, Utah

Date of Inspection: May 1, 2002  
Time of Inspection: about 1:00 to 3:00 p.m.  
Conditions: Mostly clear, 50's, windy  
Participants: Doug Jensen and Paul Baker, DOGM

## Purpose of Inspection:

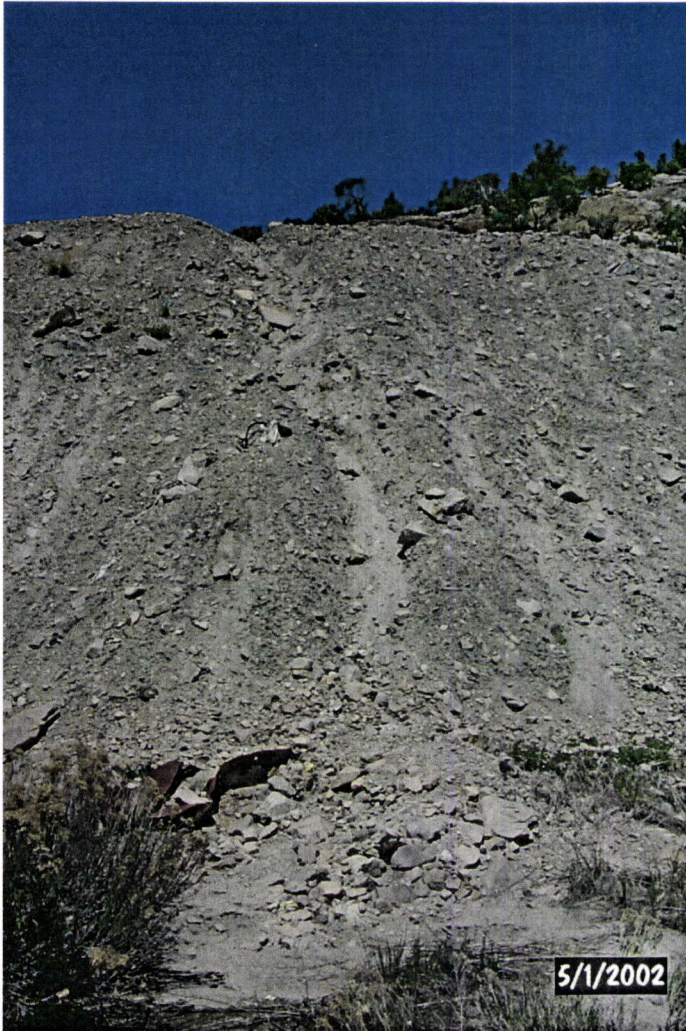
Permit M/037/026 includes both the La Sal and Snowball sites and the Beaver Shaft. At the Snowball site, there has been some erosion from the waste piles (Photo 1), and it appears some of this material has gotten into the drainage (Photo 2). Photo 3 shows some buildings at the Snowball Mine.

Photo 1. Waste pile at the Snowball Mine. Note the erosion.

The operator should install a silt fence or straw bales in the drainage below the Snowball waste pile to reduce the amount of material getting into the drainage. Otherwise, we have no other long-term maintenance suggestions.

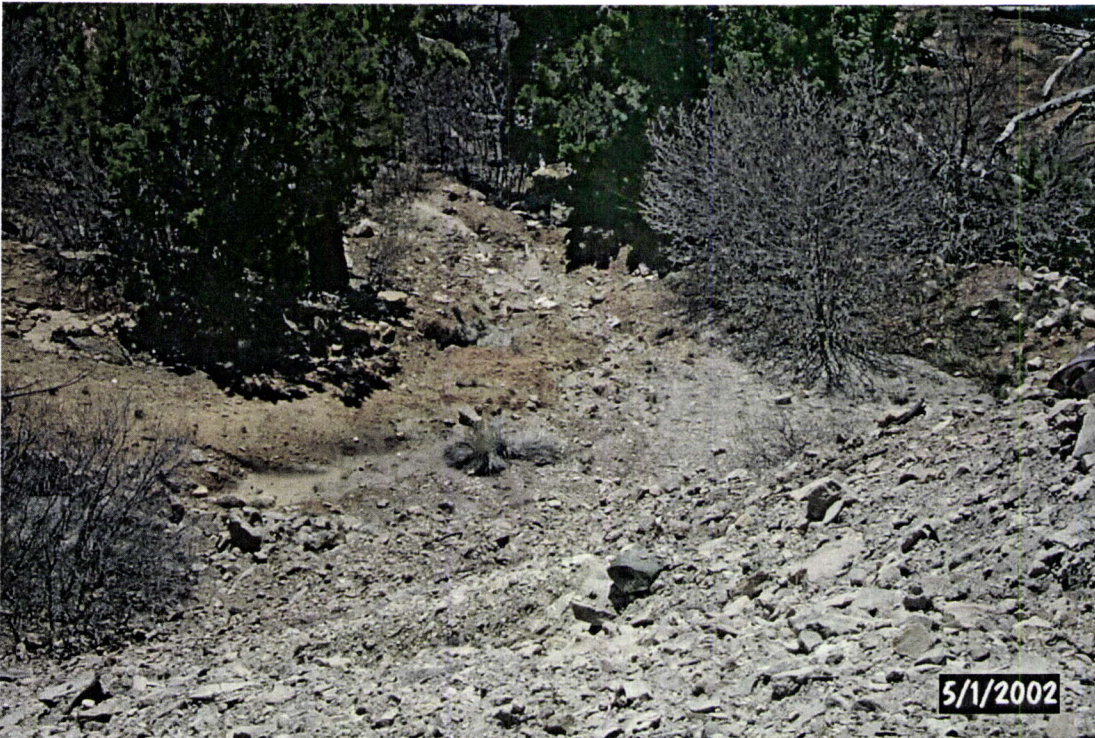
Photo 2. Sediment below the waste pile at the Snowball Mine.

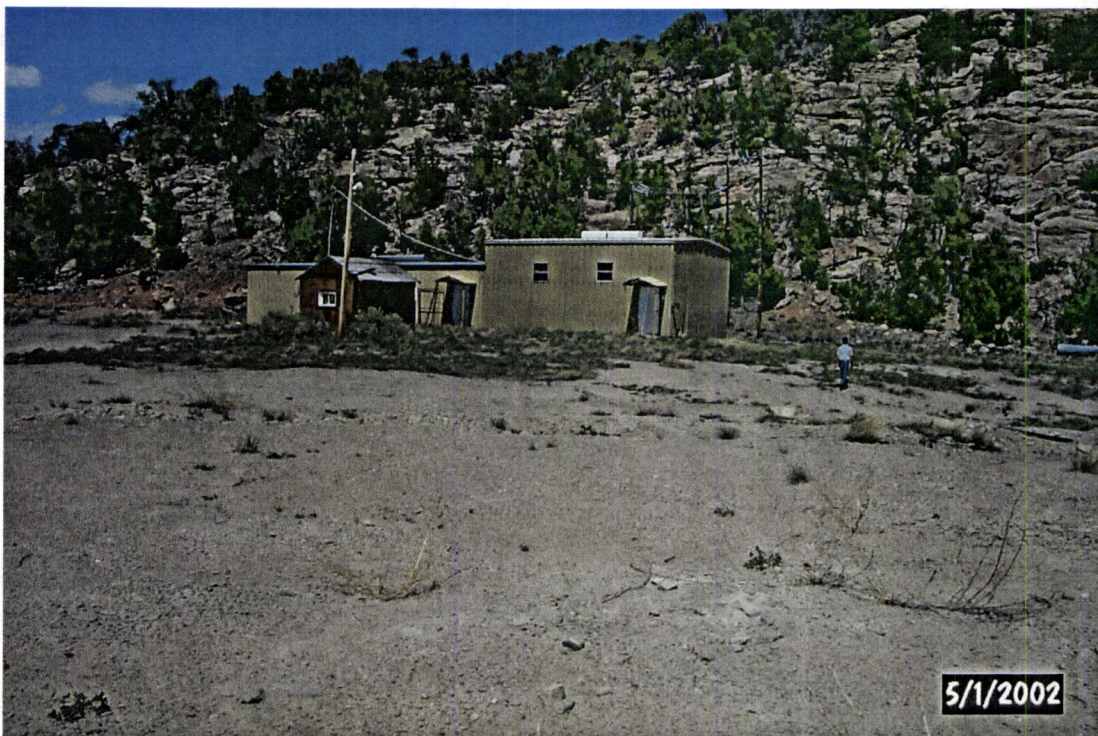
Photo 3. Buildings at the Snowball Mine.

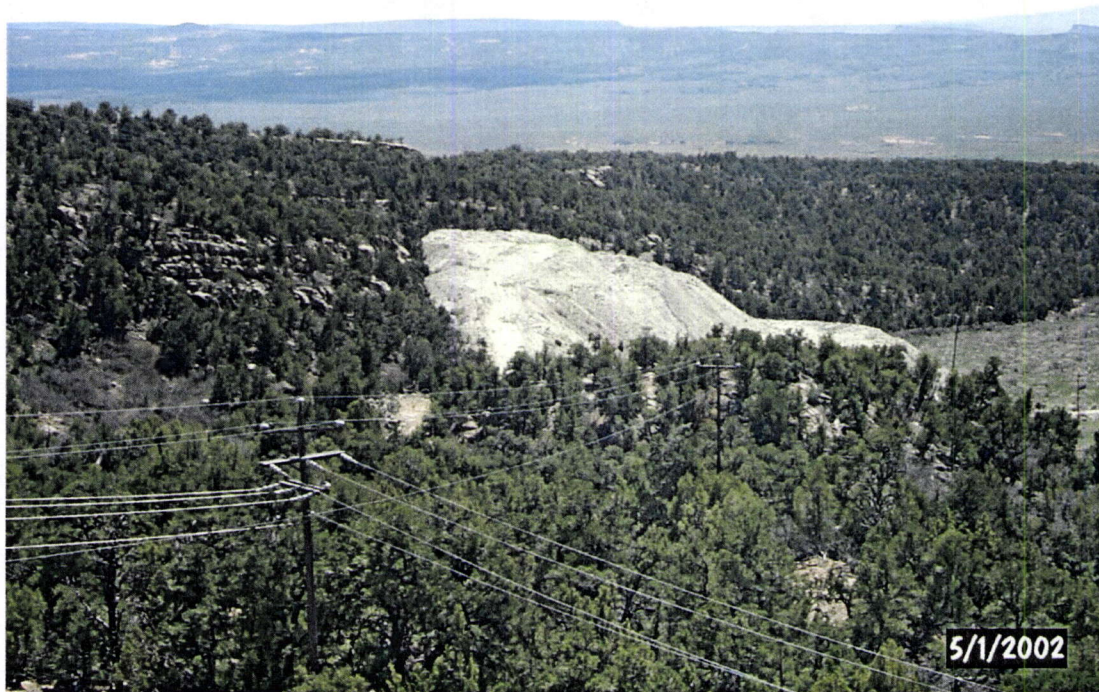
The Snowball and Pandora Mines are both in a canyon, and there would be limited space available to regrade the waste piles although there is some (Photo 4). In places where the waste was stable, there were perennial grasses, sweet clover, small burnett, and other forbs. This indicates the material has some capability of supporting vegetation if it is stable enough for the vegetation to become established. At the site east of the Beaver Shaft (Photo 5), there had been some cattle, and there was also quite a bit of vegetation establishment. It appeared from this that manure would help vegetation establishment on the waste if the waste is used as a growth medium.

Photo 4. Pandora Mine viewed from the Snowball Mine.

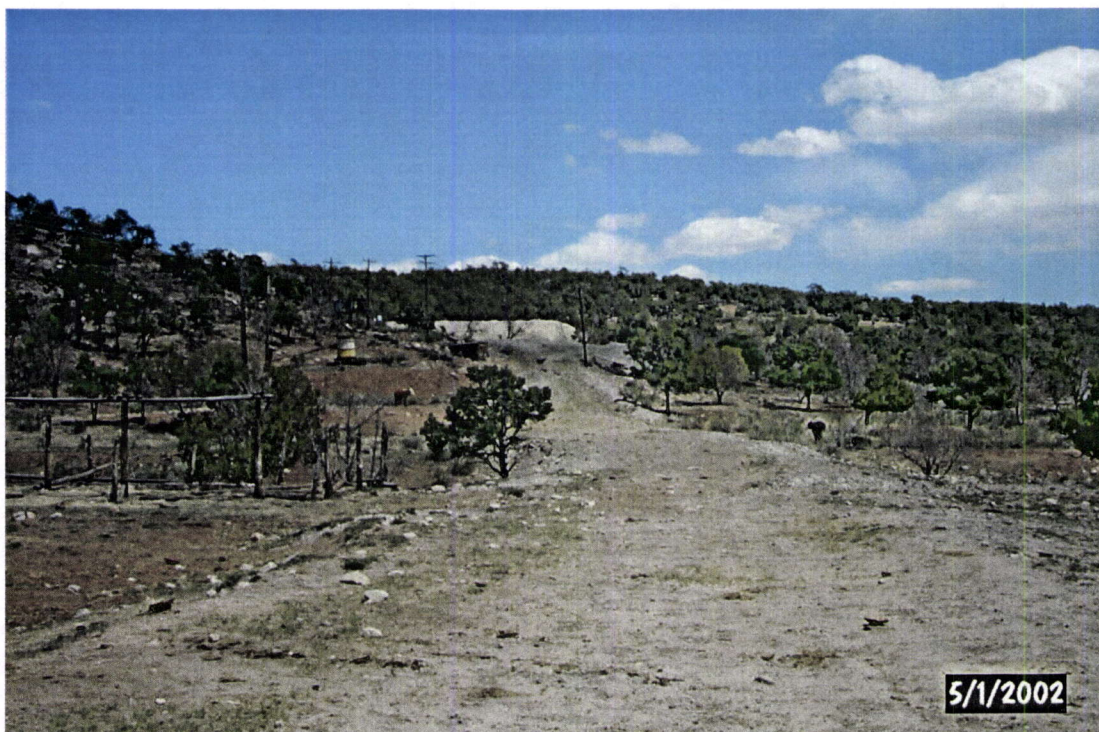
The Beaver Shaft is just north of the town of La Sal, and the headframe is easily visible from the town. There is one road leading north from the town. Take this road then turn west where it comes to a T. There is additional disturbance to the east of the T, and the entire road up from La Sal is included in the disturbed area.

Photo 5. Disturbed area east of the Beaver Shaft.
